**THESIS**

**THE EFFECT OF APPLIED TENSILE STRESS  
ON LOCALIZED CORROSION IN SENSITIZED  
AA5083**

September 2015

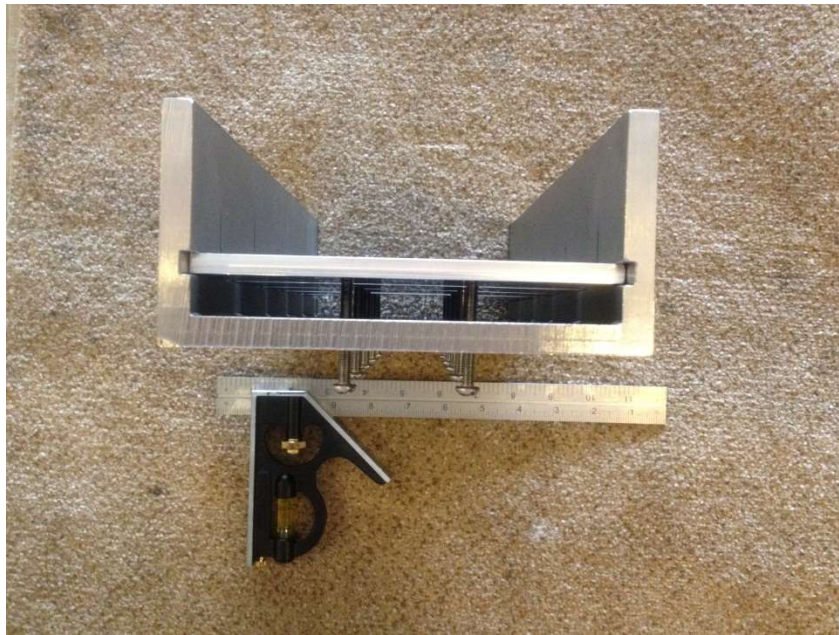
Figure 13. Photograph of stainless steel 4-point bending rig used to apply elastic stress to aluminum plate samples, from [8].

The four point bending apparatus was designed in accordance with ASTM-G39 (see Figure 12). The bend rig was made of 316 stainless-steel and utilized #10 stainless steel screws with 32 threads per inch to apply stress to the aluminum coupons (see Figure 13).

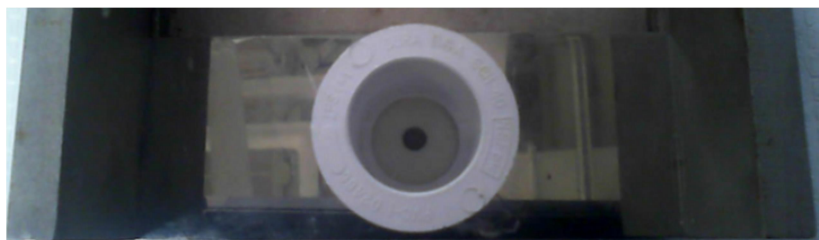
Figure 15. Top view of cup mounted to top of sample with double-sided tape. The area exposed to saltwater is punched through the tape.
